BC | Climate Resilience
Summit 2025

Post-wildfire geohazards can occur immediately after the wildfire

Lesson 1 – geohazard assessment of ~2000 properties required urgent practitioner support to community-led response – with emergency assessments refined into detailed work for recovery.

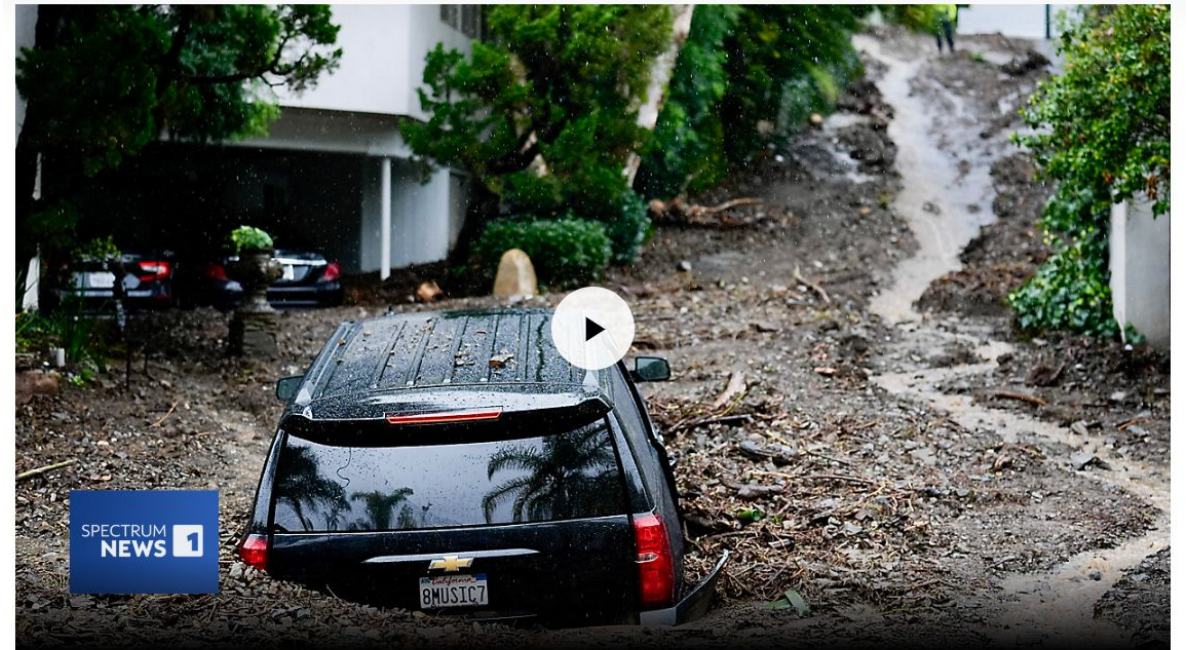
Debris flows and debris floods
January 27 & February 13, 2025

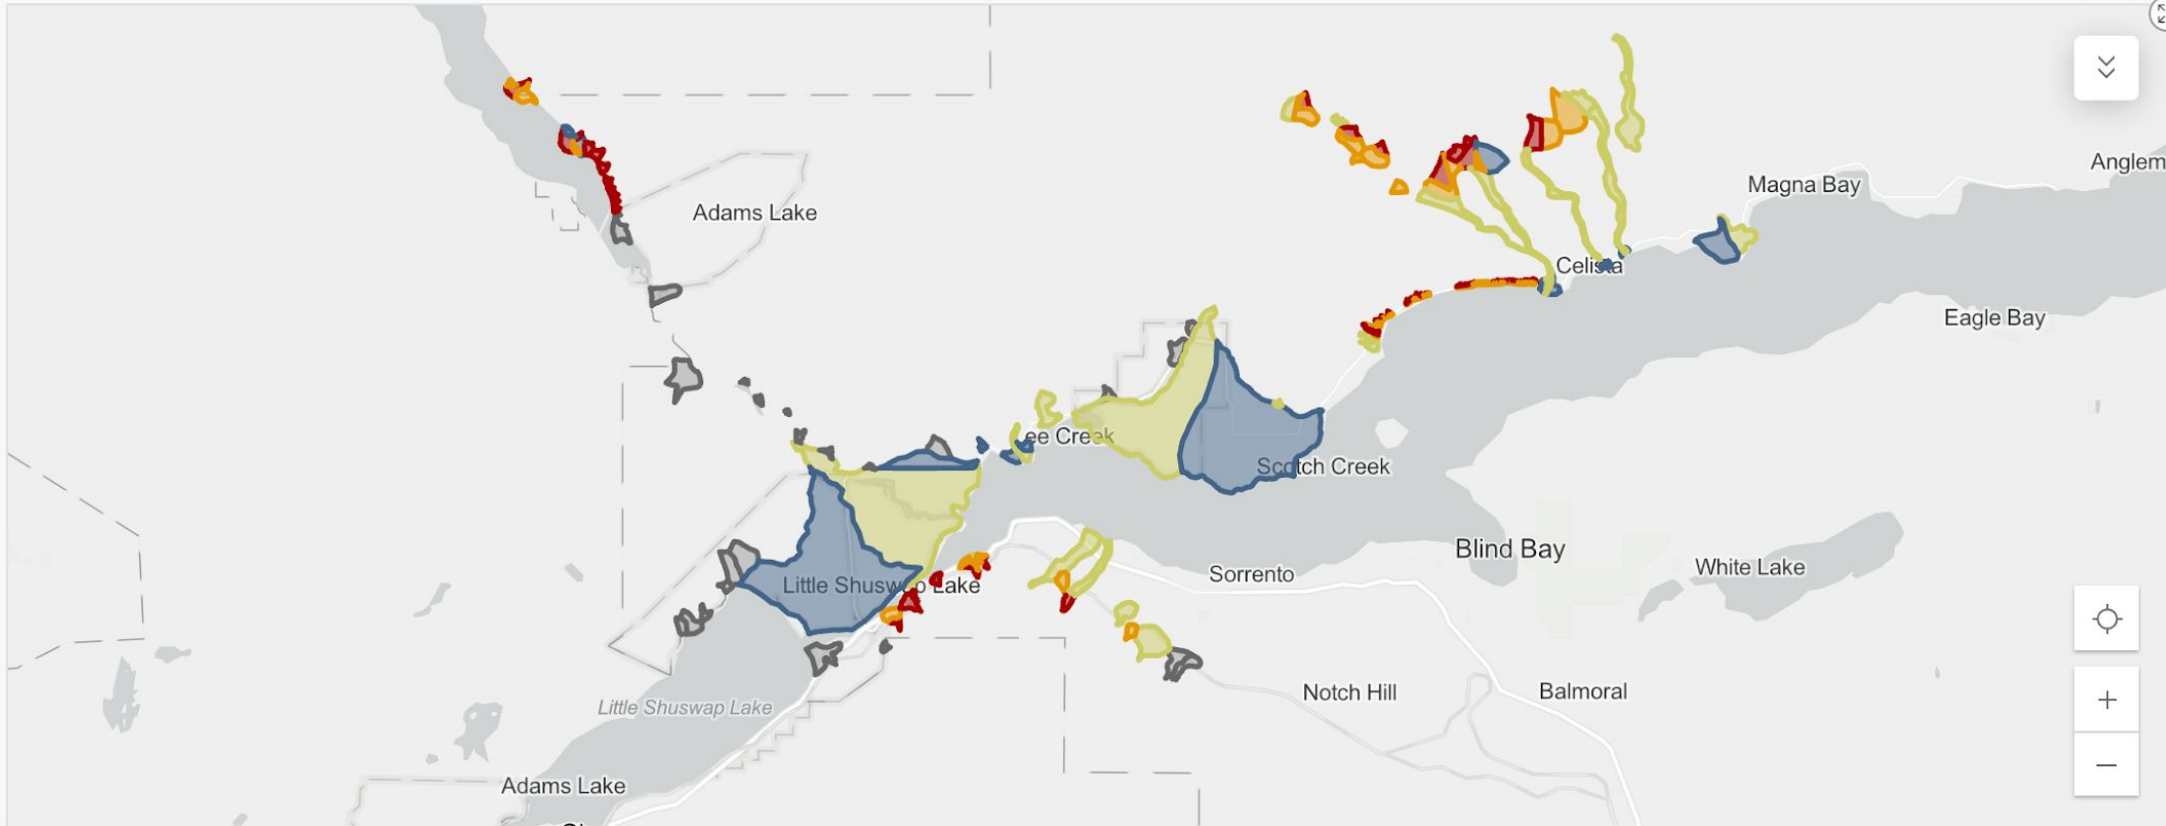
Red Hazard Zone
122
 Red Hazard Zone Properties in the CSRD

Orange Hazard Zone
112
 Orange Hazard Zone Properties in the CSRD

Yellow Hazard Zone
707
 Yellow Hazard Zone Properties in the CSRD

Blue Hazard Zone
1.5k
 Blue Hazard Zone Properties in the CSRD

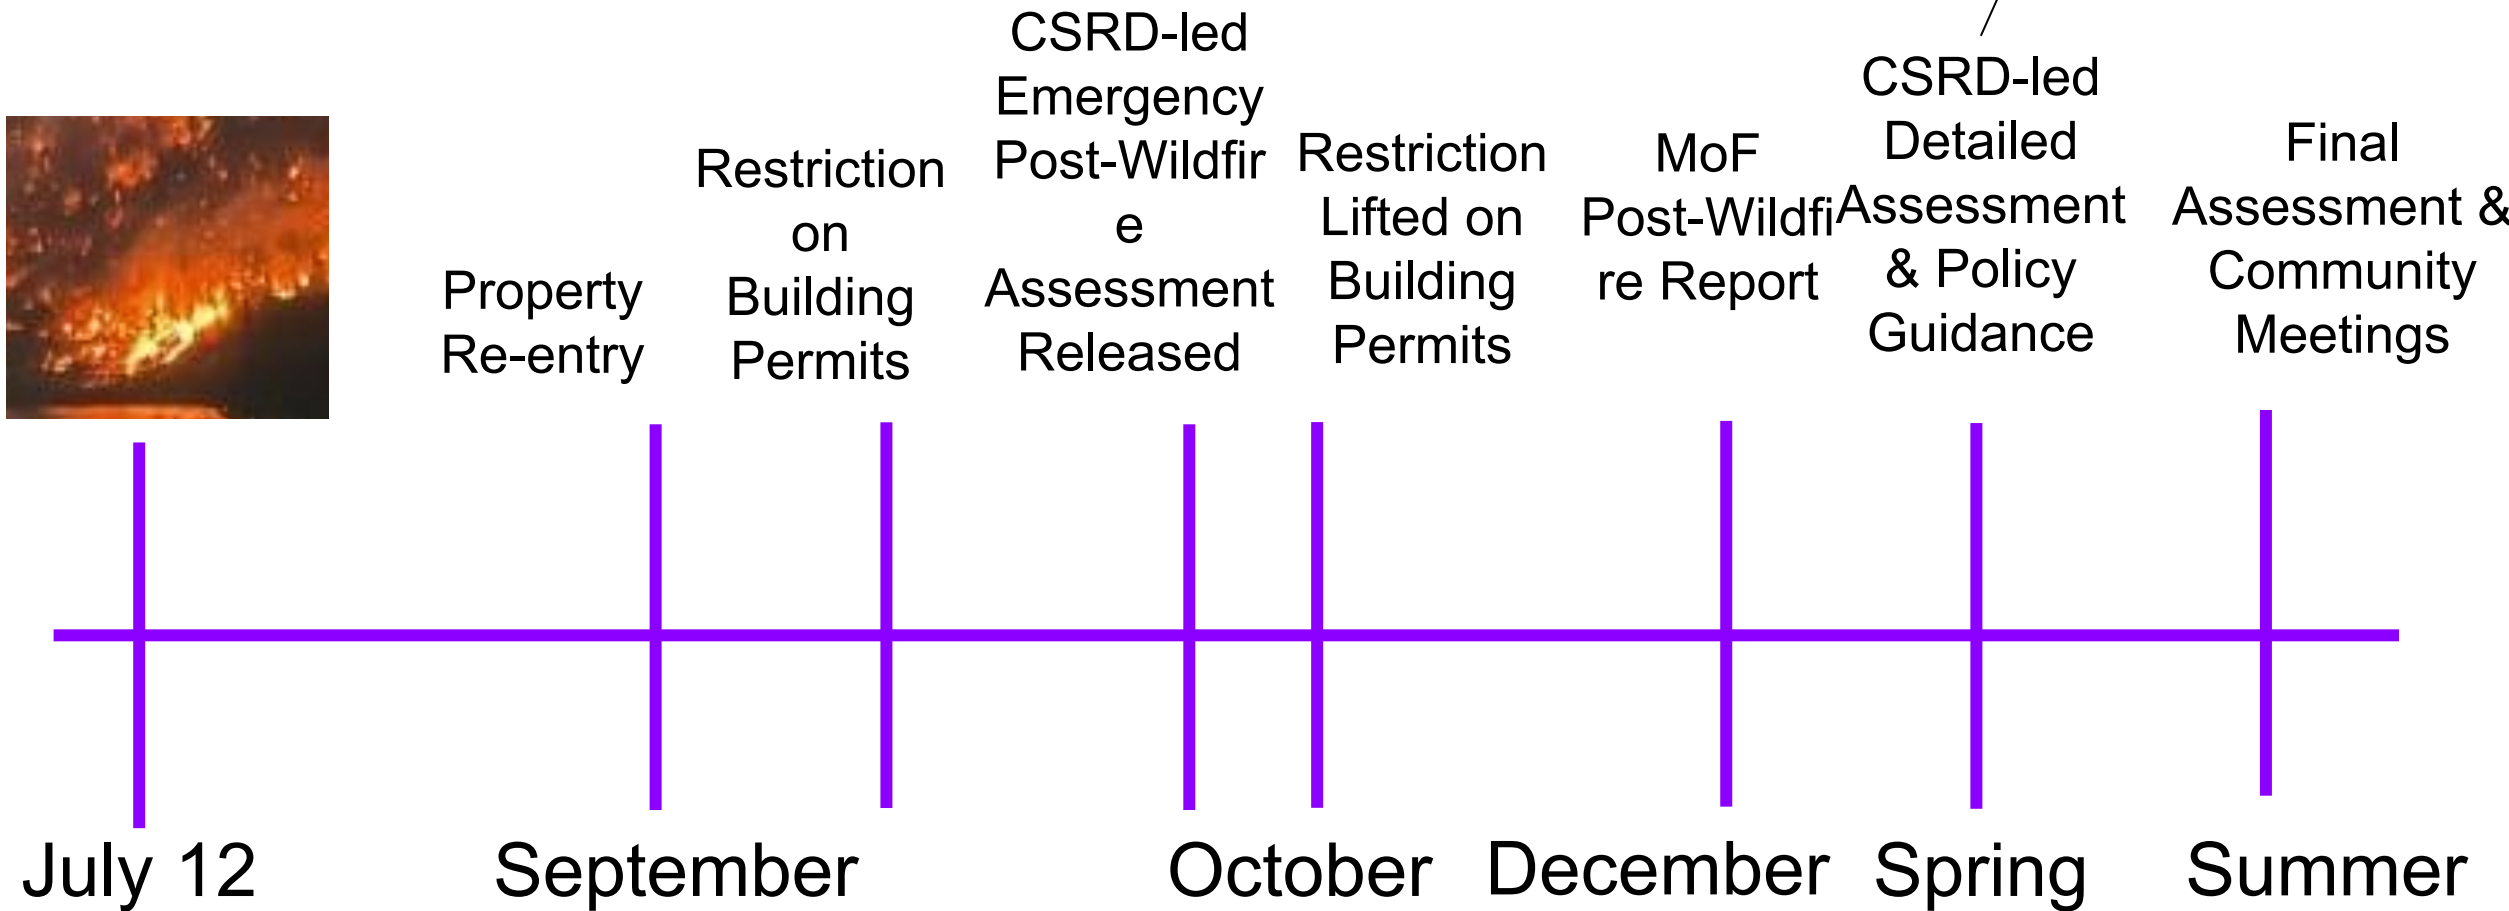
Lesson 2 – Development policy is tested after wildfire – mapping regional baseline risk before the fire and using consistent criteria to re-assess changed conditions will accelerate policy decisions.

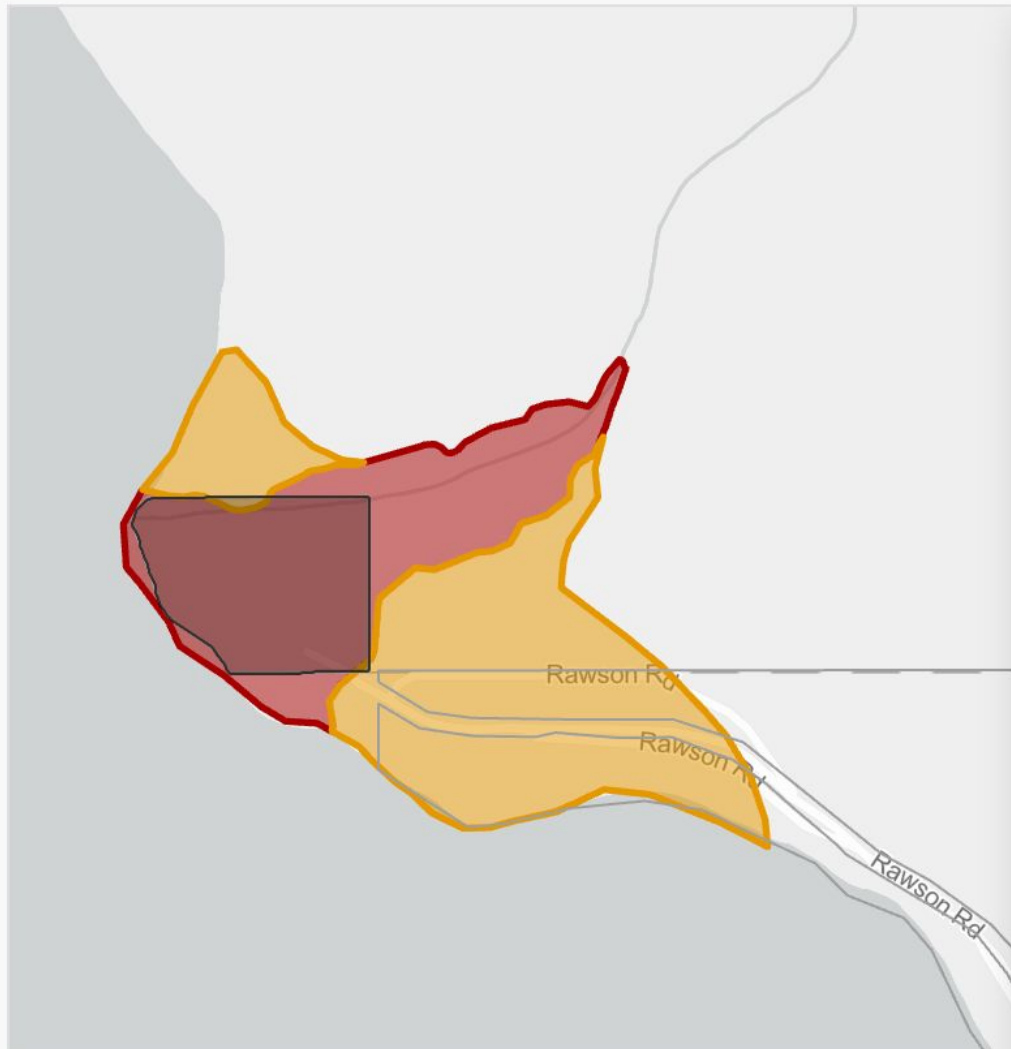
Hazard Zone: Red
Address: 2992 Rawson Rd
PID: 014-299-755

Geographical Area: Adams Lake East
Inundation Likelihood: Deep (> 1 m) and fast-moving (>2 m/s) debris flows are expected to reach buildings.
Potential Damages: Building damage may cause fatalities
